Manhole Inspection Summary

Manhole # S35KK1018MH

Insp Date: **3/12/07 11:18 AM**

Location Address: **221 NORTHWAY**

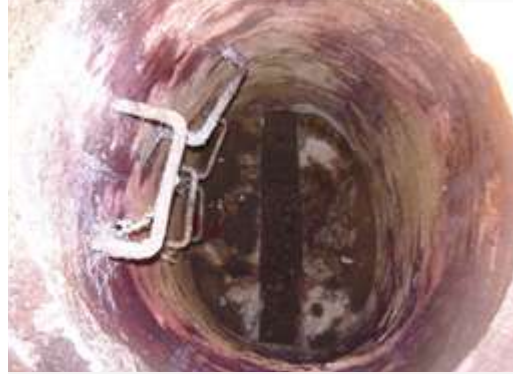
Top View

Corroded steps. Bench and Channel debris.

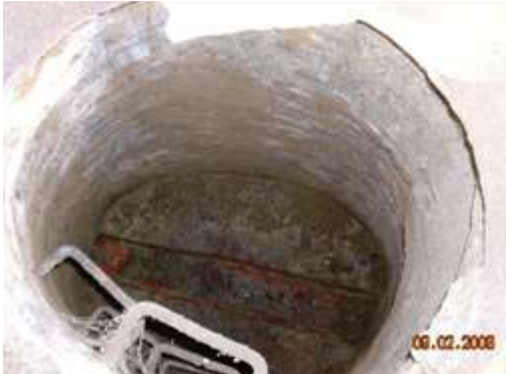
Defect

Frame leaks. Corbel and Barrel infiltration - other side.

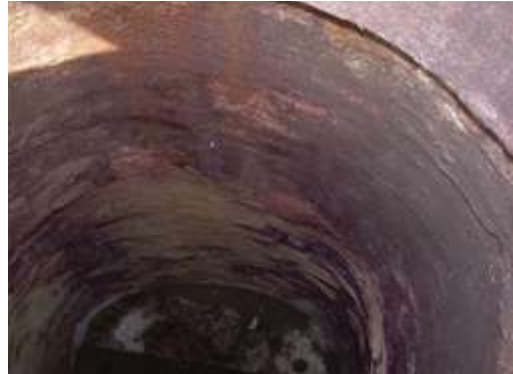
Defect

Frame leaks. Corbel and Barrel infiltration.

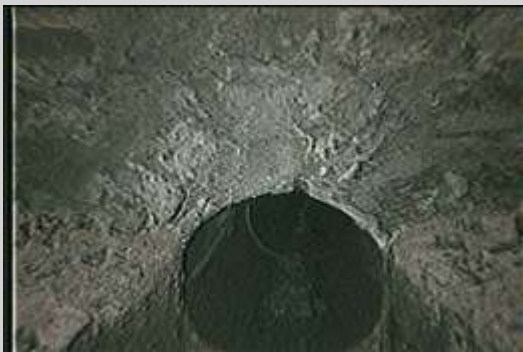
6 in. Circular Gravity Sewer Pipe Out @ 12 O'Clock

Infiltration: **None** Pipe Seal Cond: **Unknown**

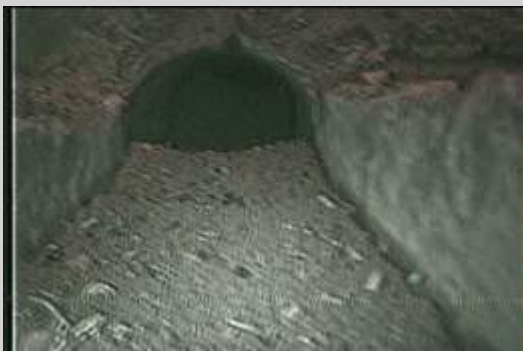
8 in. Circular Gravity Sewer Pipe In @ 6 O'Clock

Infiltration: **None** Pipe Seal Cond: **Broken**

Connects To: **Stub connection / abandoned**
